## PROPELLER MODIFICATIONS

### TRAILING EDGE ADJUSTMENT FOR HEAVY RUNNING PROPELLERS

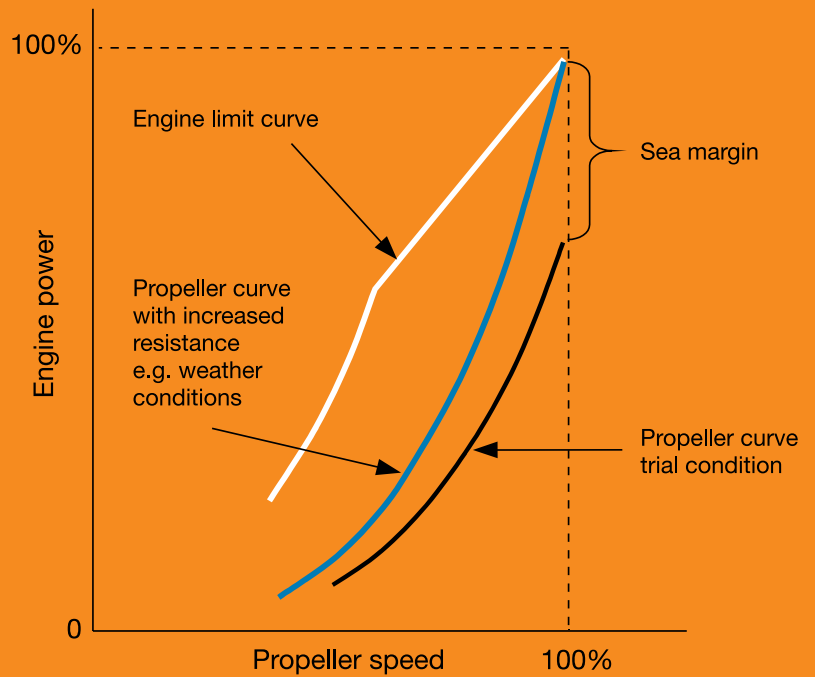
Fig. 1 The engine loading diagram in a regular situation.

gas temperatures as well as increased wear of pistons, liners and valves, resulting in high maintenance costs. It may also be impossible to maintain the vessel’s operational speed, which may cause problems with schedules. Figure 1 shows the engine loading diagram for a regular situation. The propeller’s pitch is selected so that 85 % of the MRC power is generated at 100 % nominal shaft speed. This creates a sea margin to accommodate any

increase in the ship’s resistance due to the weather. Full power can be generated at full rpm in service conditions (including the sea margin).

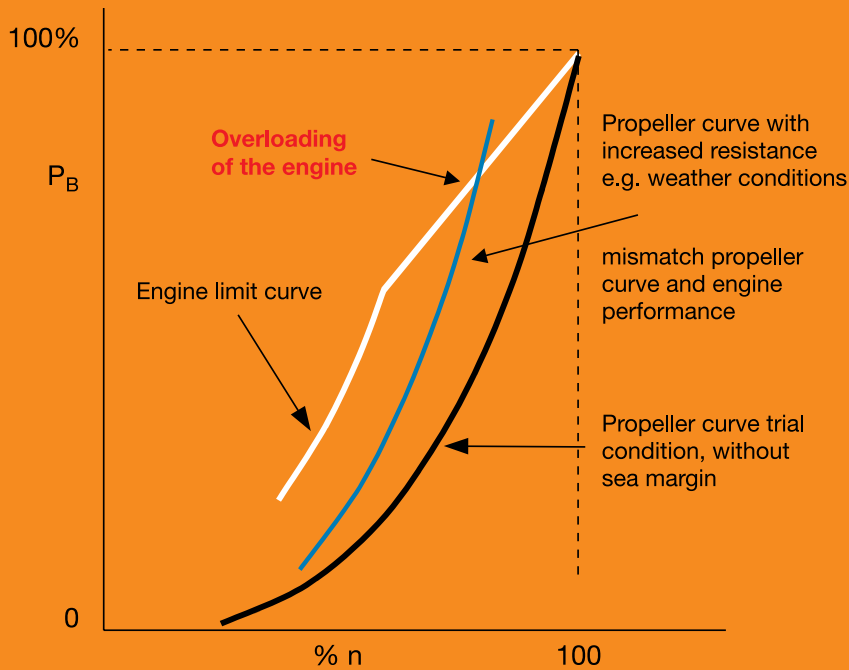
Fig. 2 The engine loading diagram for a heavy running propeller.

The engine loading diagram for a heavy running propeller is shown in Figure 2. For some reason, the propeller's power absorption in trial conditions may show only a small or even a non-existent sea margin. If the ship's resistance increases now, the engine will run in overload. At low propeller speeds, the power demand is larger than the engine can deliver; the propeller's power curve crosses the engine load limit before the full power of the engine is reached.

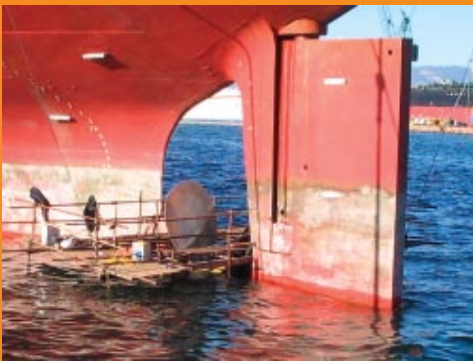
Trailing edge adjustment at pier side.

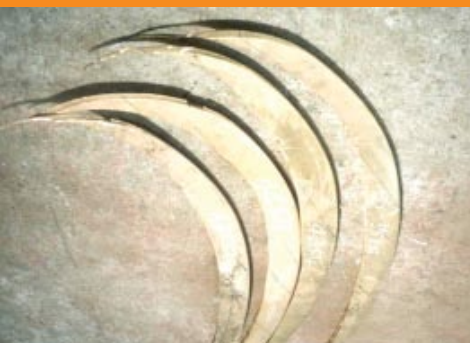
Equal pieces of propeller material are cut off.
